World Trade Center Building Performance Study:

*Data Collection, Preliminary
Observations, and
Recommendations*

FEMA 403 / May 2002

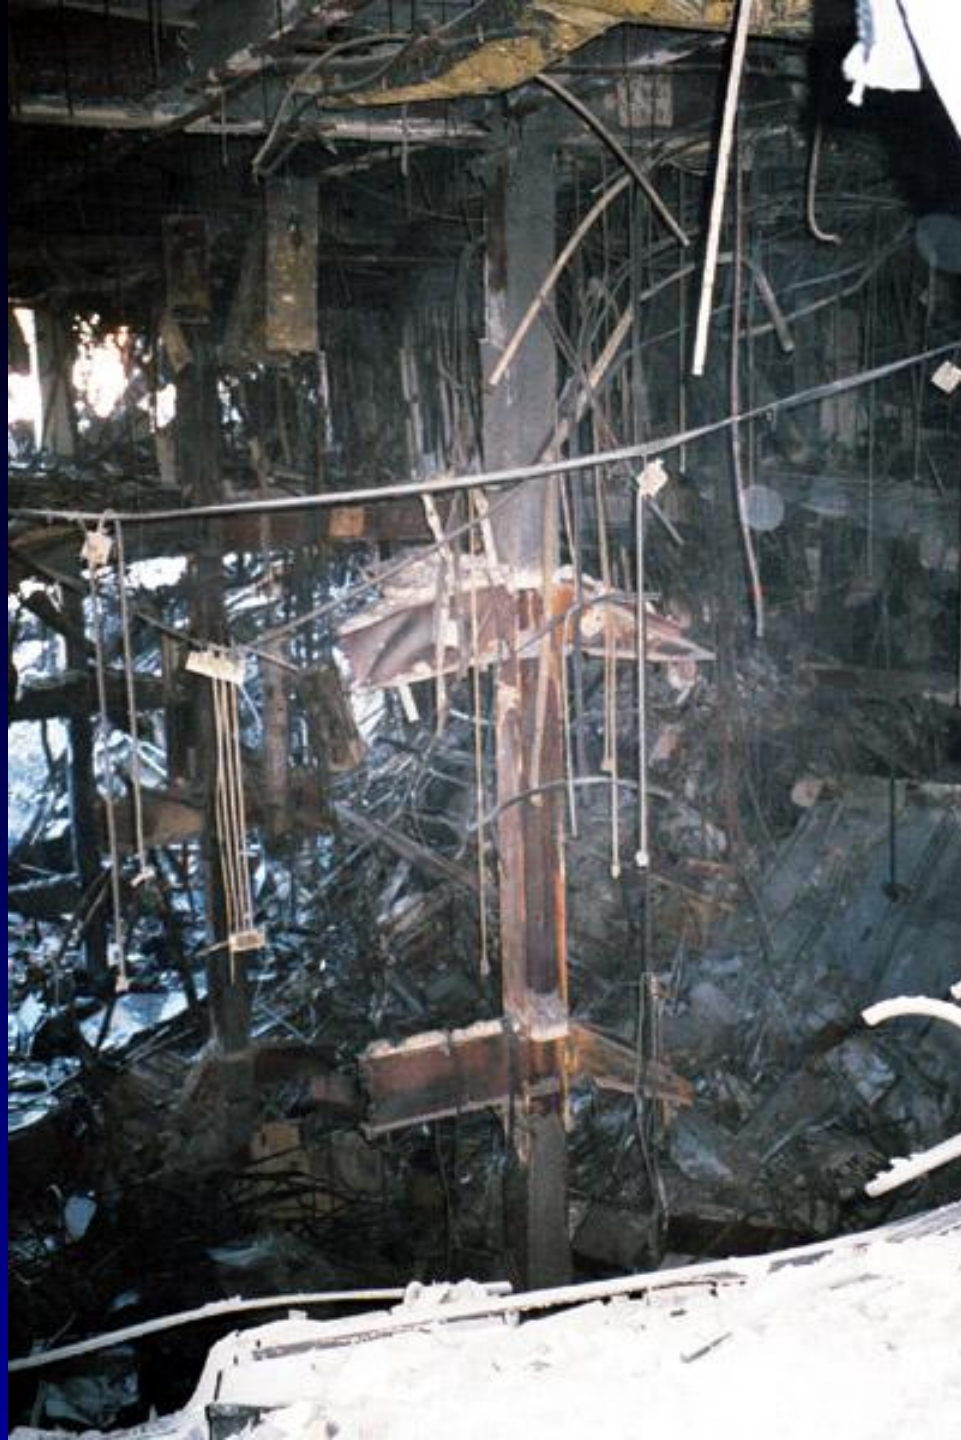
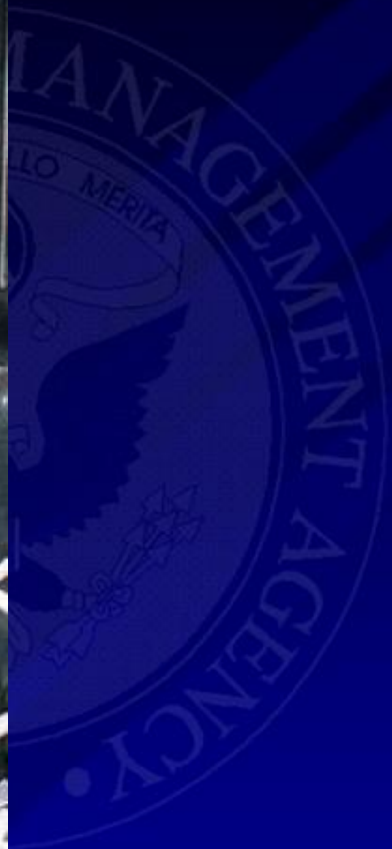
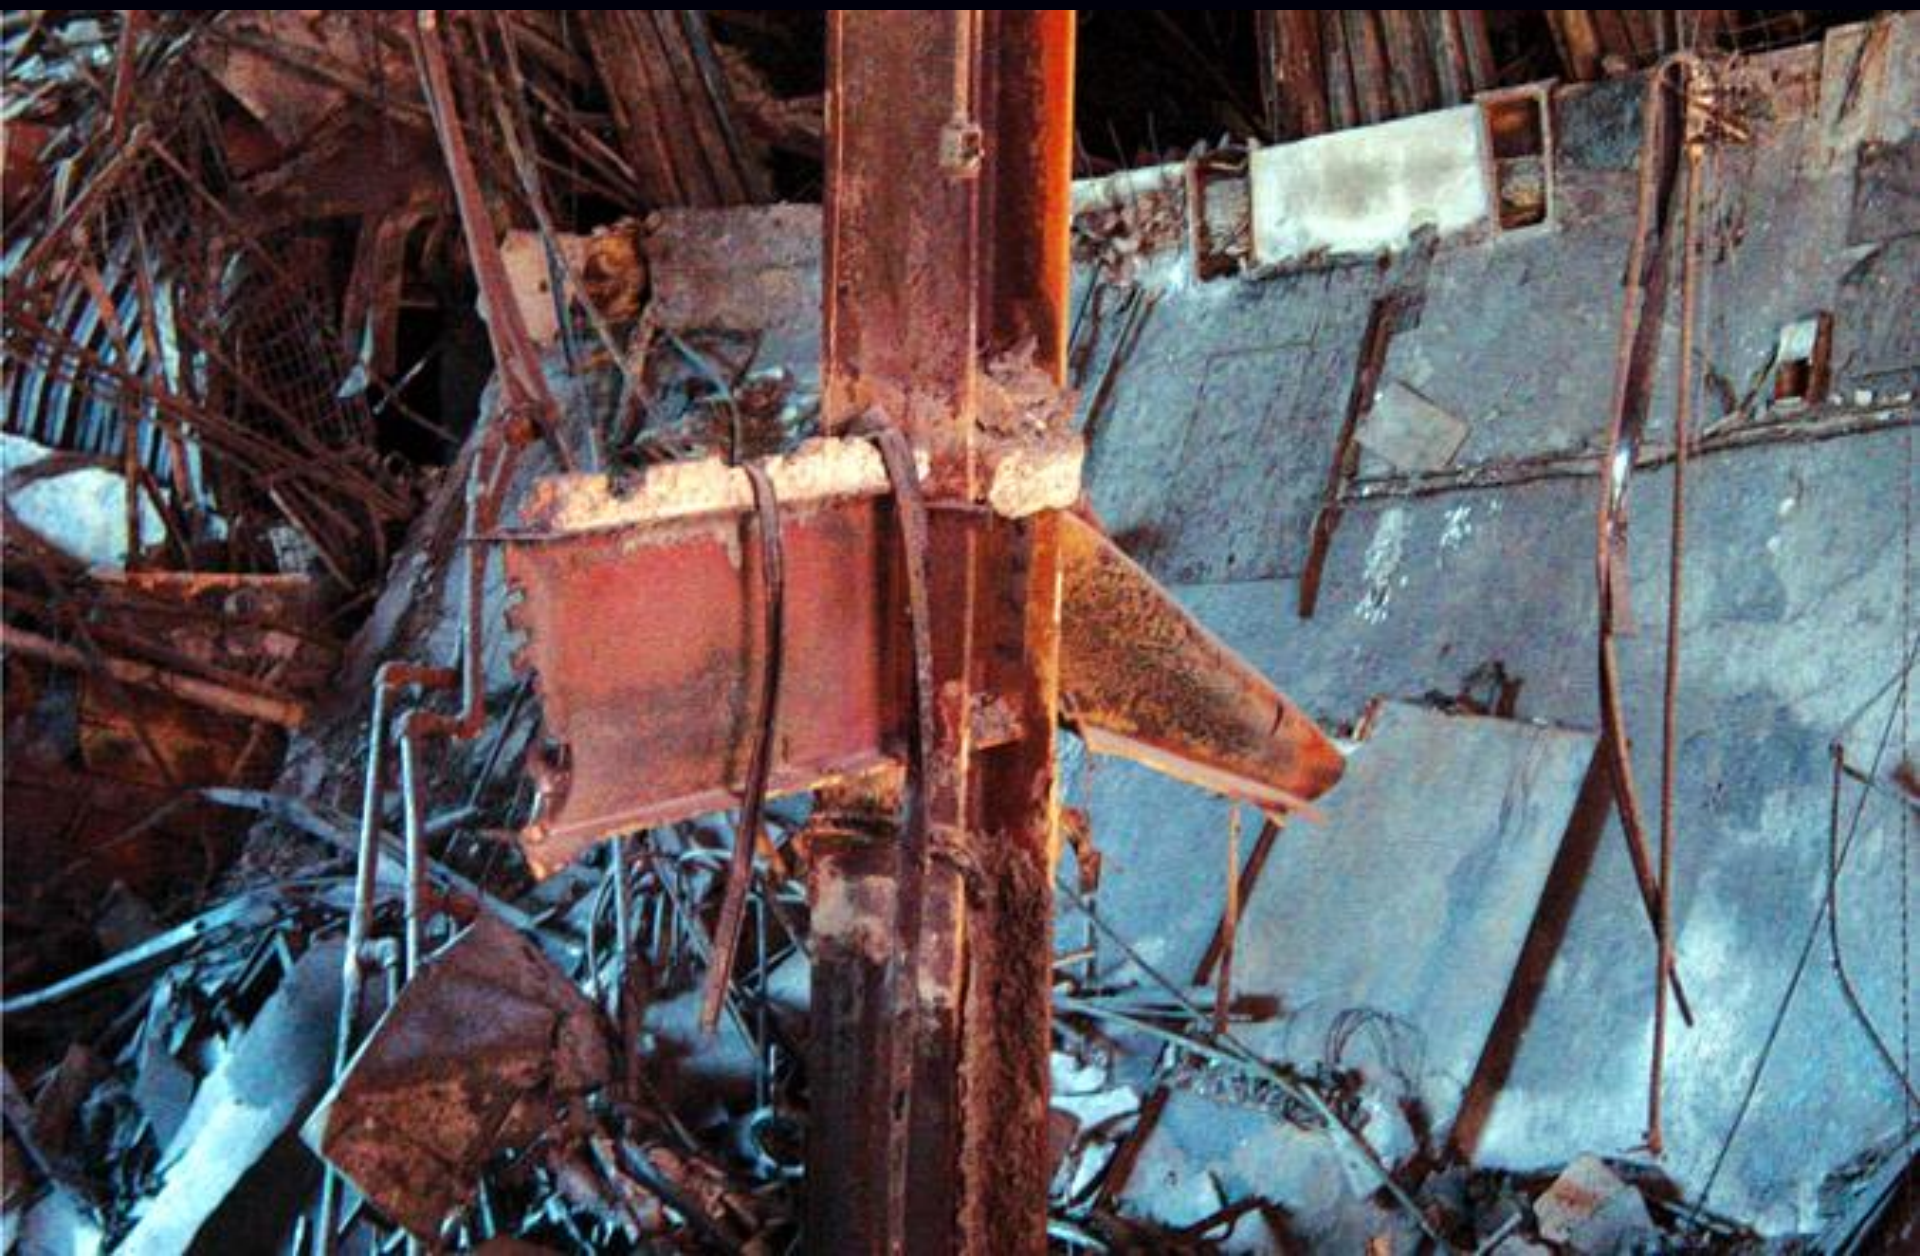
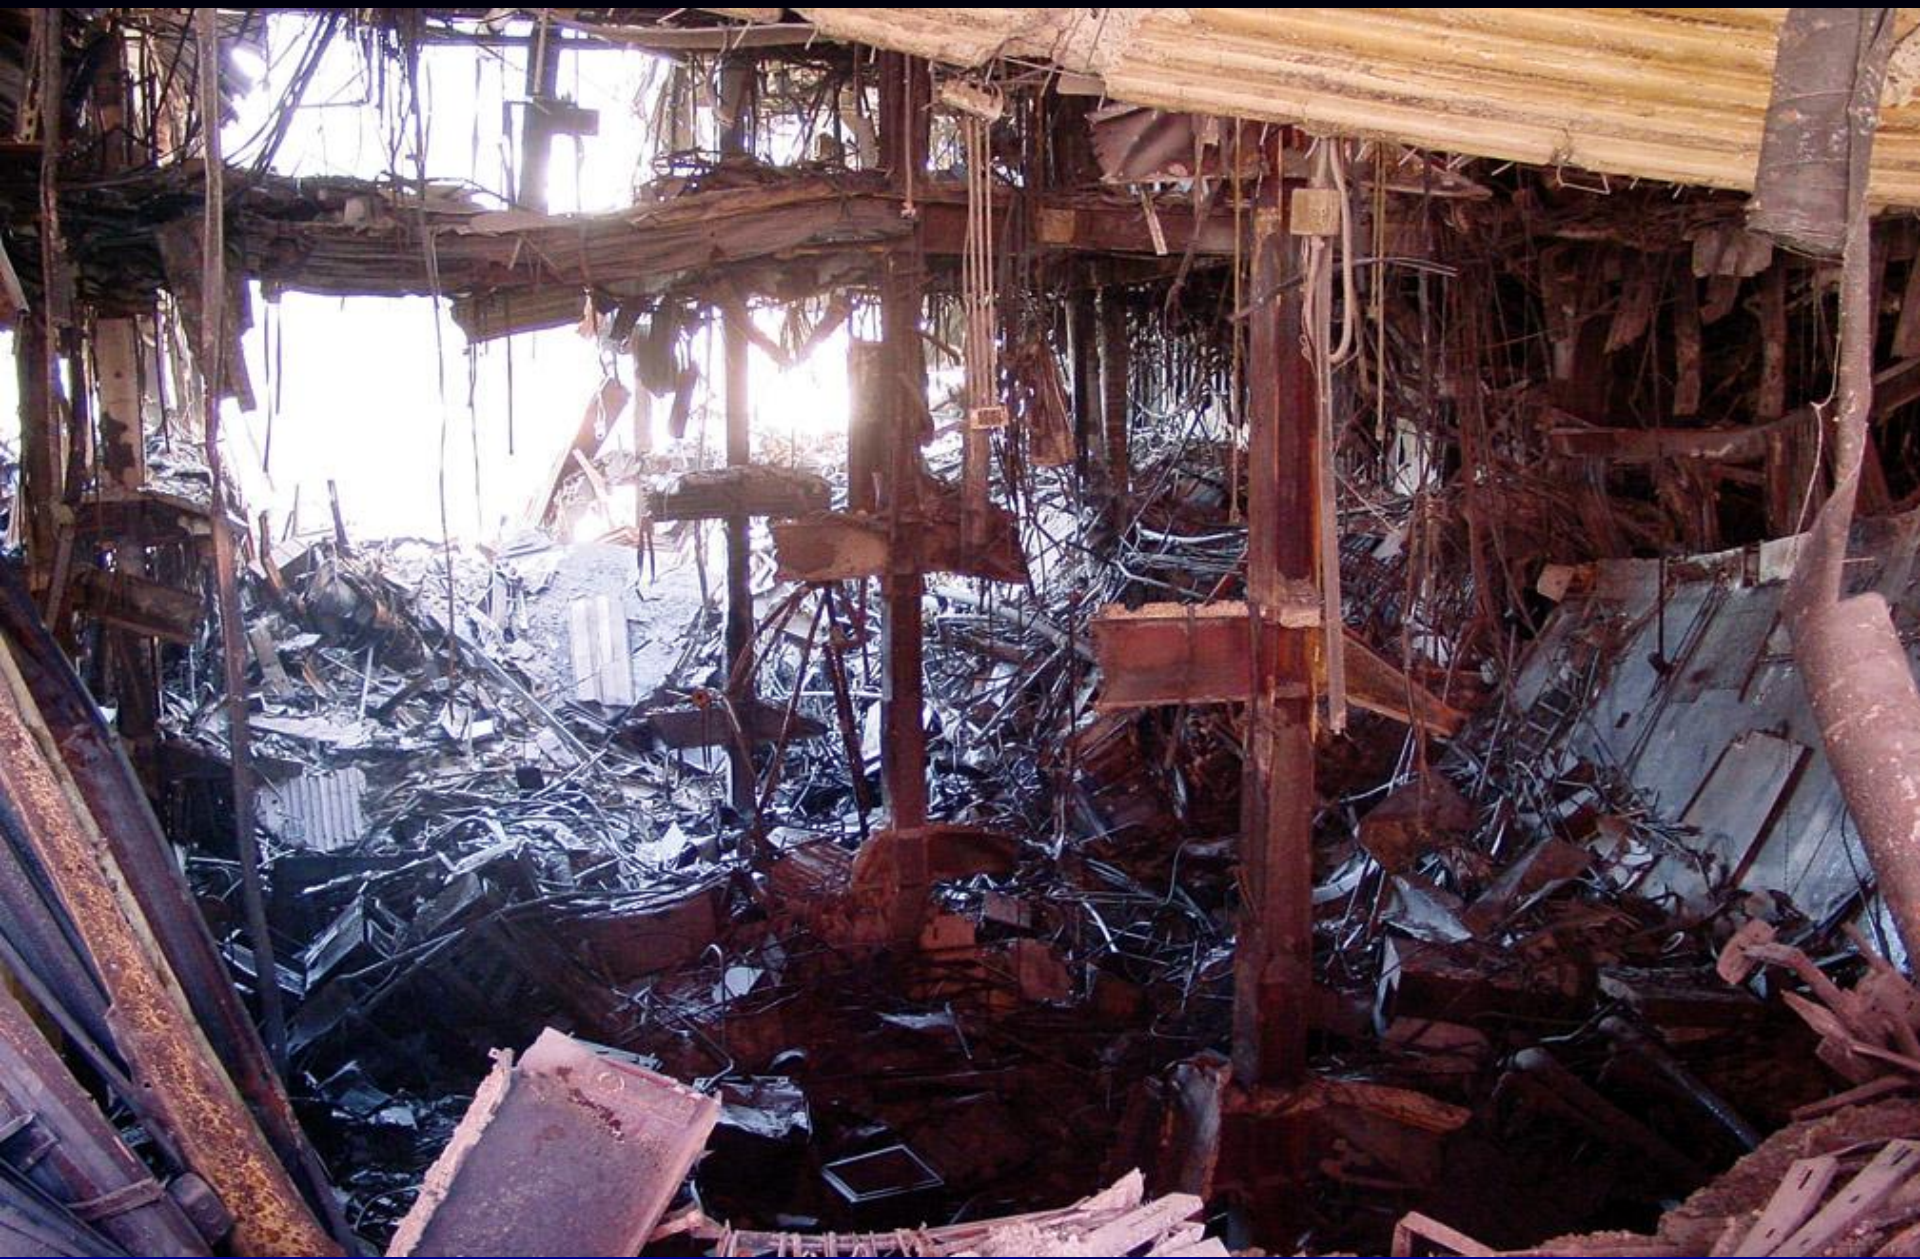
**Failed Column-Tree
Connections**

- Conduct further studies to determine the performance of connections and their adequacy under real fire exposures.
- Determine the combined structural and fire properties of the critical structural connections so that predictions of their behavior under overload conditions can be made. This can be accomplished with a combination of thermal transfer modeling, structural finite element modeling (FEM), and full-scale physical testing.

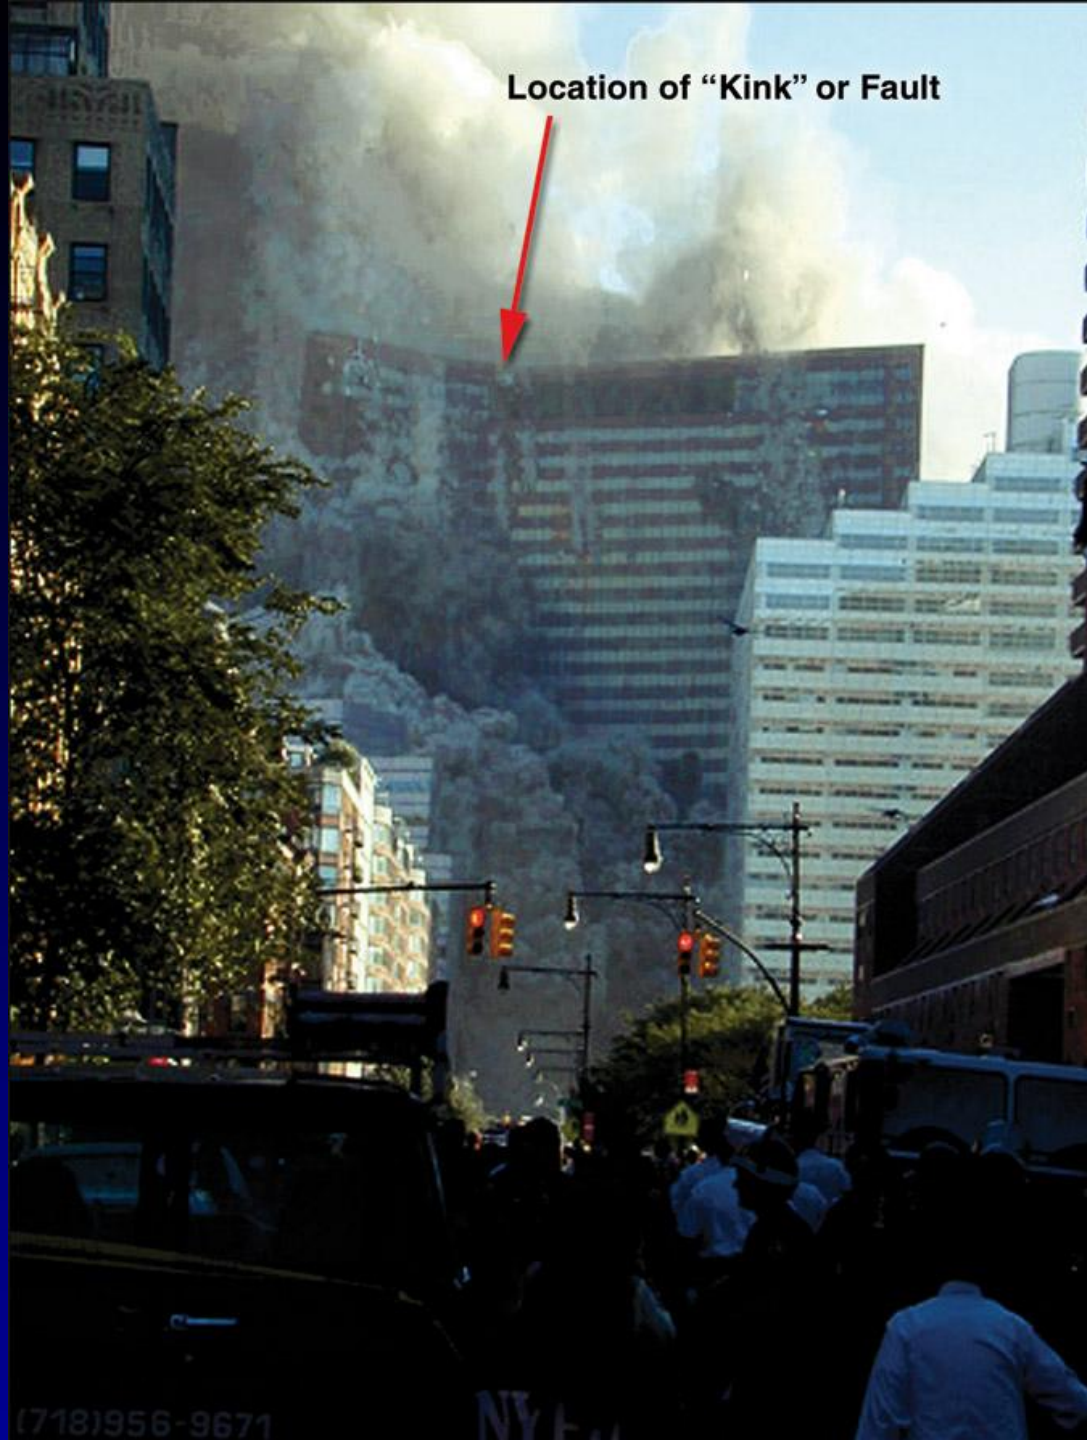
Location of "Kink" or Fault
